Debris/Ice/TPS Assessment And Integrated Photographic Analysis For Shuttle Mission STS-52

December 1992

DEBRIS/ICE/TPS ASSESSMENT
AND
PHOTOGRAPHIC ANALYSIS
OF
SHUTTLE MISSION STS-52

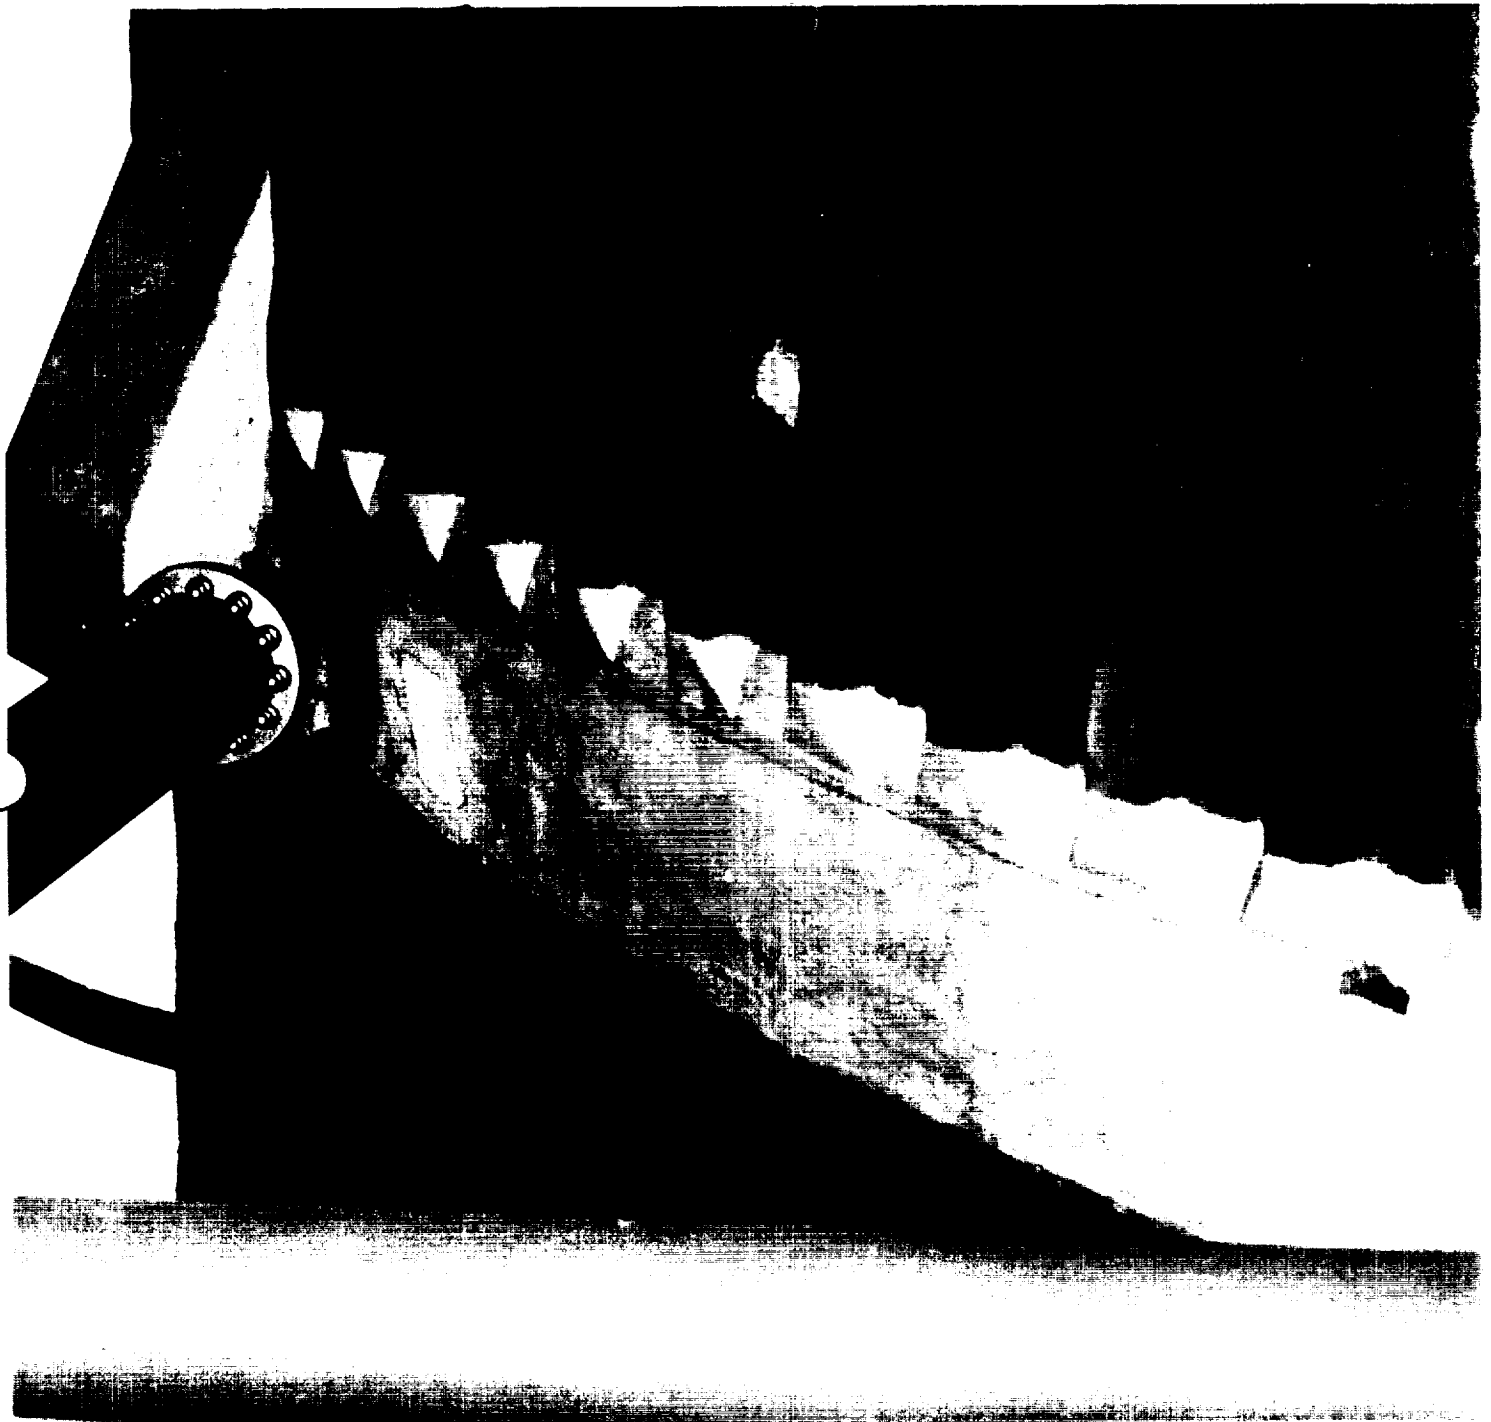
Pre-flight configuration of the bipod jack pad closeouts, the intertank TPS acreage, and the LH2 tank flange closeout. Post ET separation photography would reveal the loss of TPS from the intertank acreage and the LH bipod jack pad closeout.

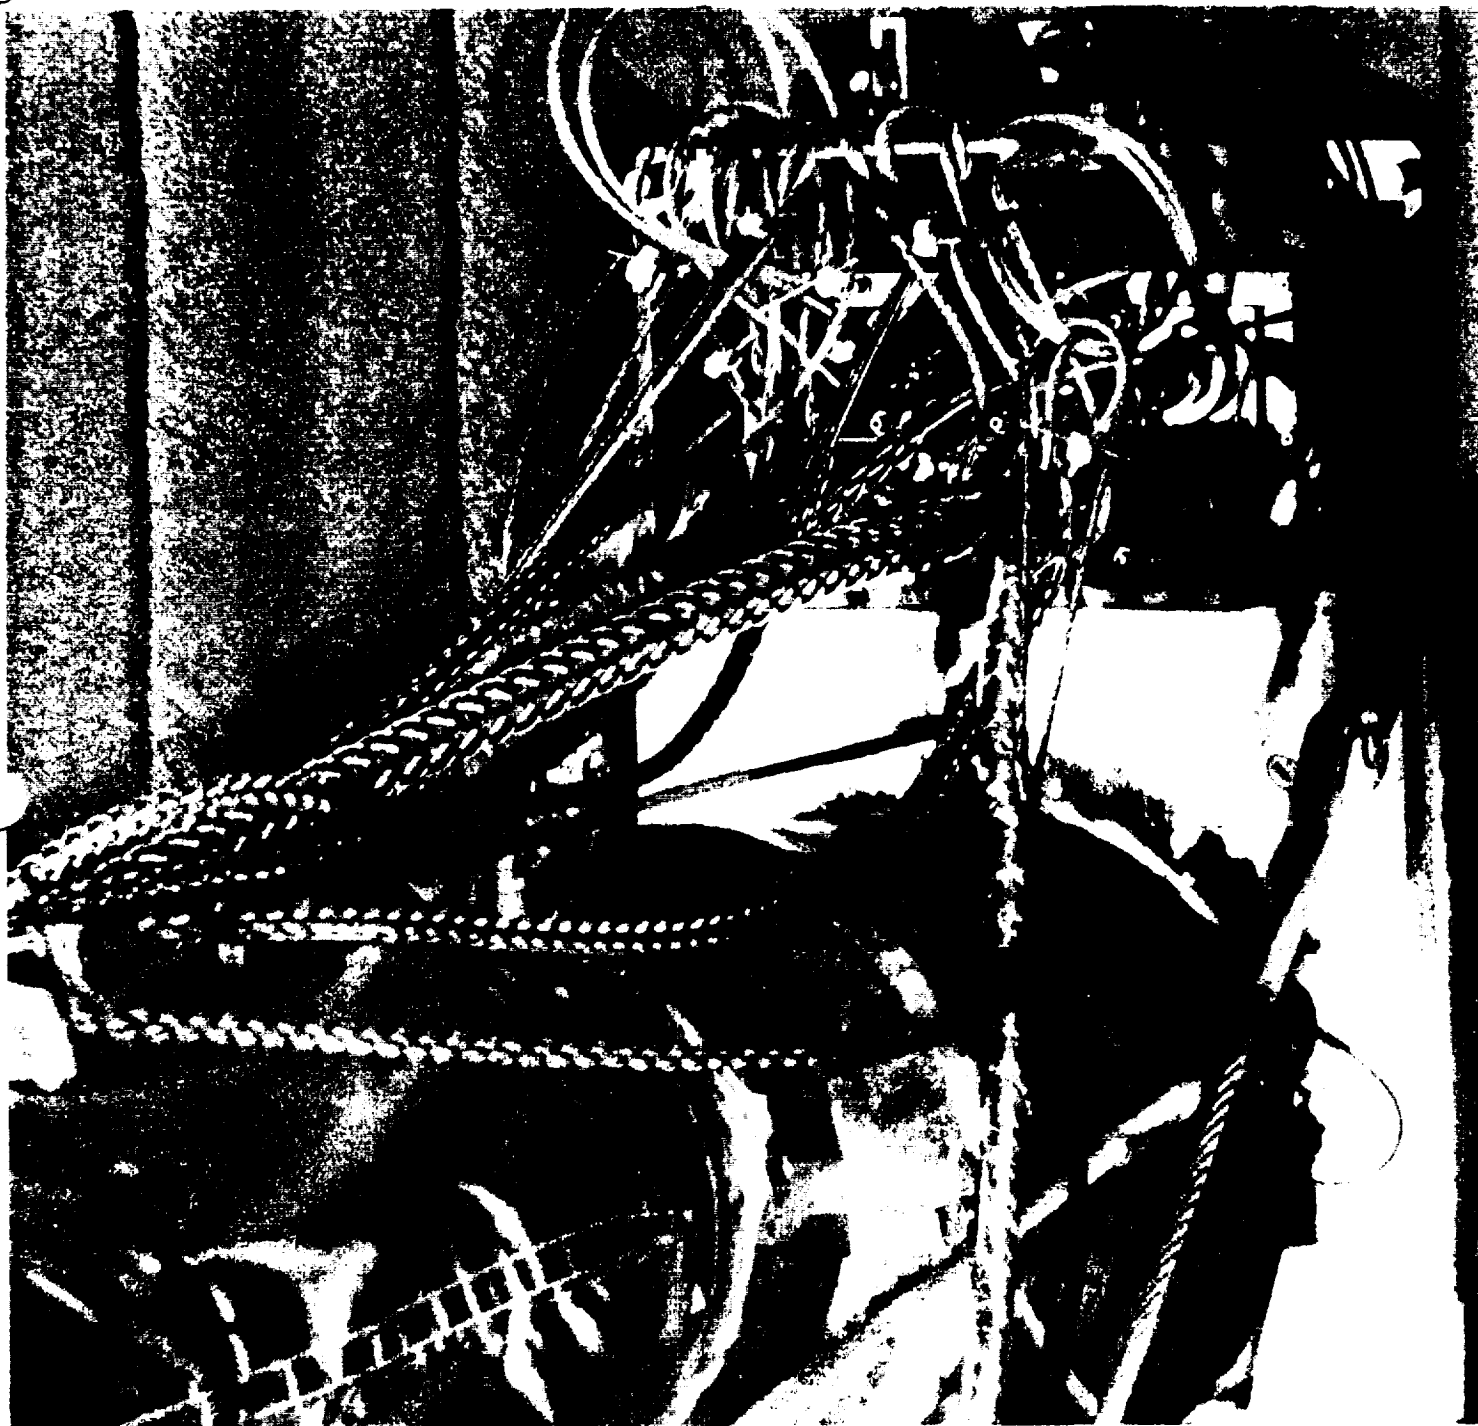
A hydrogen leak external to the vent line occurred from cryogenic loading slow fill through stable replenish. More than usual amounts of ice and frost covered the uninsulated areas of the GUCP around the 7-inch line. Post launch inspection and retest of the GSE hardware did not reveal any anomalies.

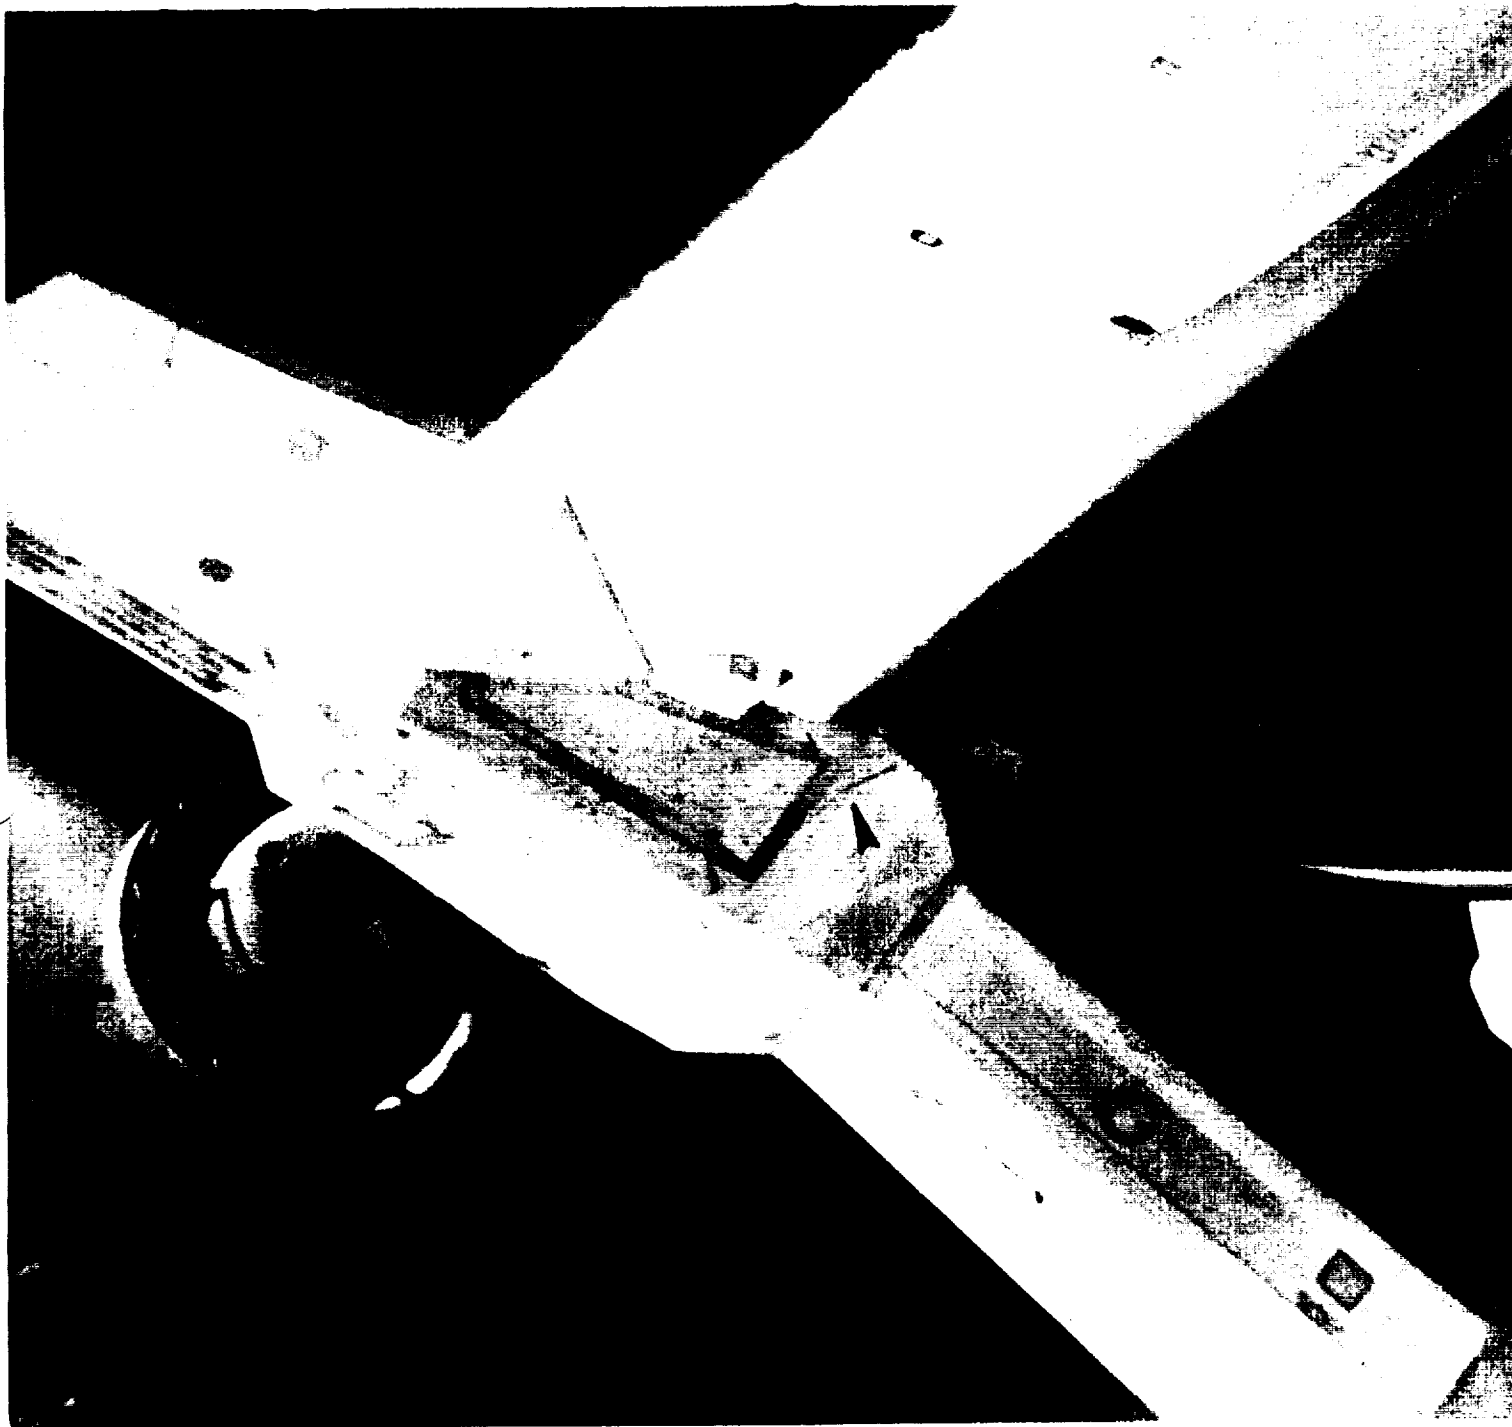
An 8-inch long dogleg crack was present in the forward surface TPS covering of the -Y vertical strut cable tray near the longeron closeout interface. The 3/8-inch wide crack exhibited no offset and was not filled with ice or frost. The appearance of the crack was expected due to the elimination of the stress relief gap at the factory.

Anomaly 003 documented an 8-inch dogleg crack in the forward surface TPS covering of the -Y vertical strut cable tray at the intersection to the ET/SRB cable tray transition fairing. The 3/8-inch wide crack exhibited no offset and was not filled with ice or frost. The condition was acceptable for launch per NSTS-08303 and CR S041254C.

An 8-inch long dogleg crack appeared in the LH (-Y) vertical strut/cable tray forward facing TPS covering near the longeron closeout interface. A stress relief cut in the TPS to allow for structural movement had been deleted by design. This condition was acceptable for flight per the NSTS-08303 criteria

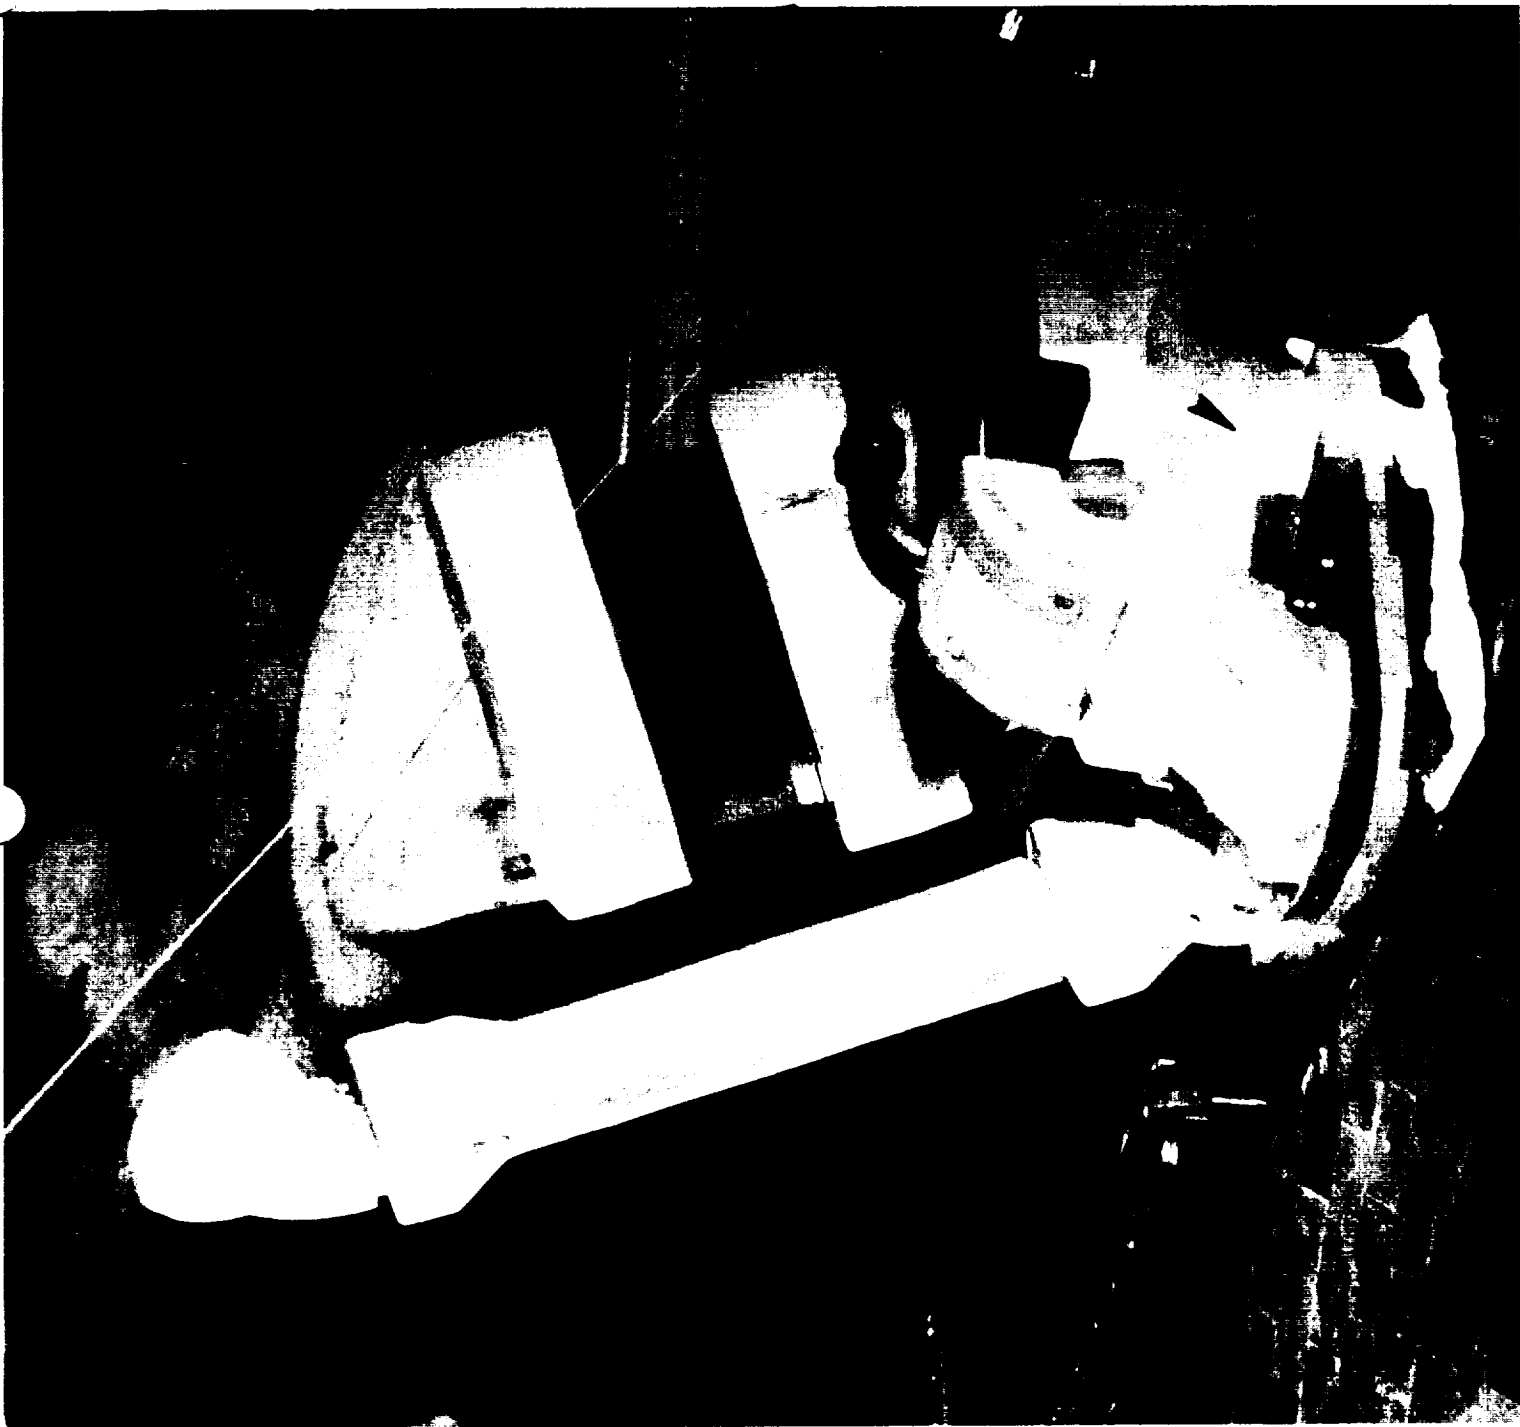
Anomaly 001 documented an apparent crack at the upper outboard pyro canister TPS closeout aft bondline on the LH2 ET/ORB umbilical. Although the area was covered by ice and frost, the condition was acceptable per the NSTS-08303 criteria.

Typical amounts of ice/frost had formed on the top and outboard sides of the LH2 ET/ORB umbilical/purge barrier. Normal amounts of ice had accumulated on the plate gap and pyrotechnic canister purge vents, and the LH2 recirculation line bellows. Ice was present on the forward outboard pyrotechnic canister closeout bondline indicating a thermal short (arrow).

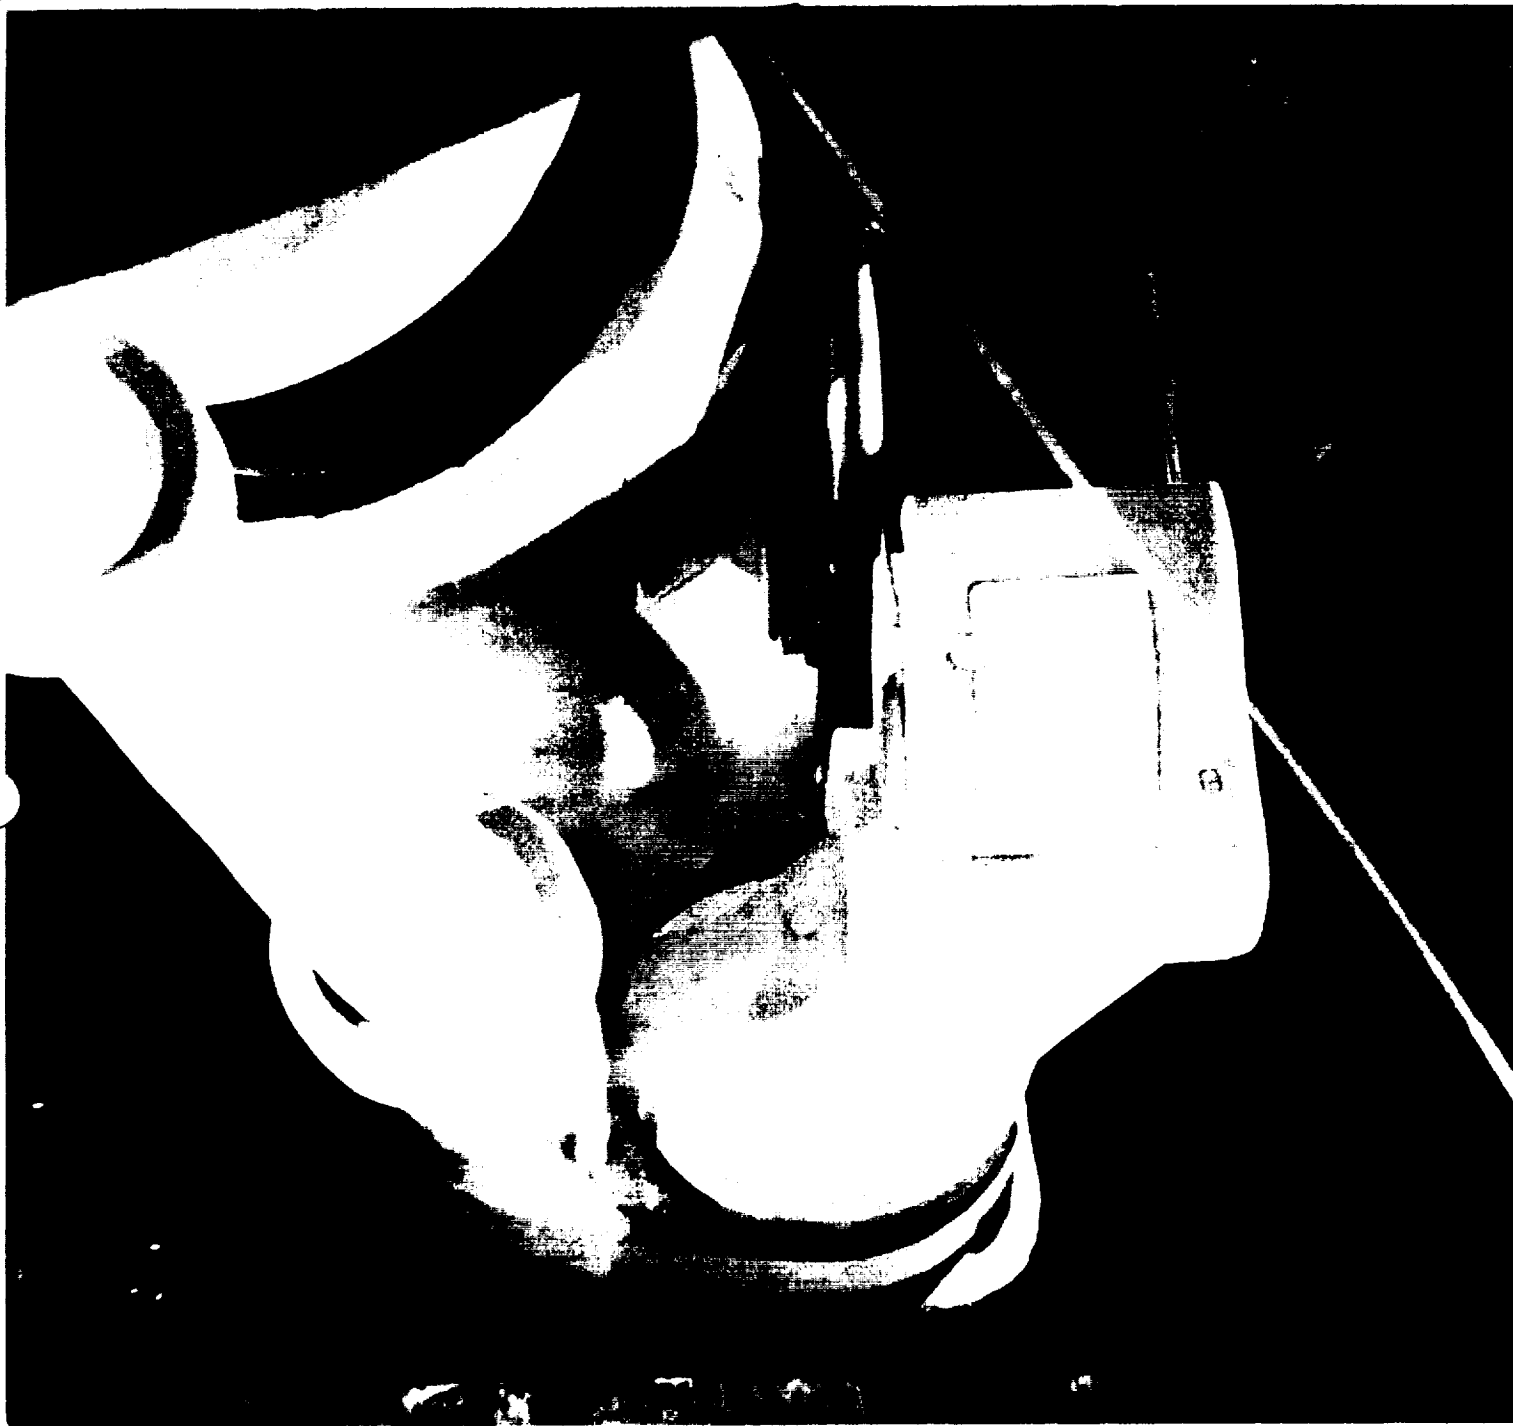
Typical in size, ice/frost fingers had formed on the aft plate gap purge vent and LH2 umbilical cable tray vent hole. The lack of ice or frost on the 17-inch flapper valve actuator access port foam plug closeout indicated a tight seal and nominal closeout.

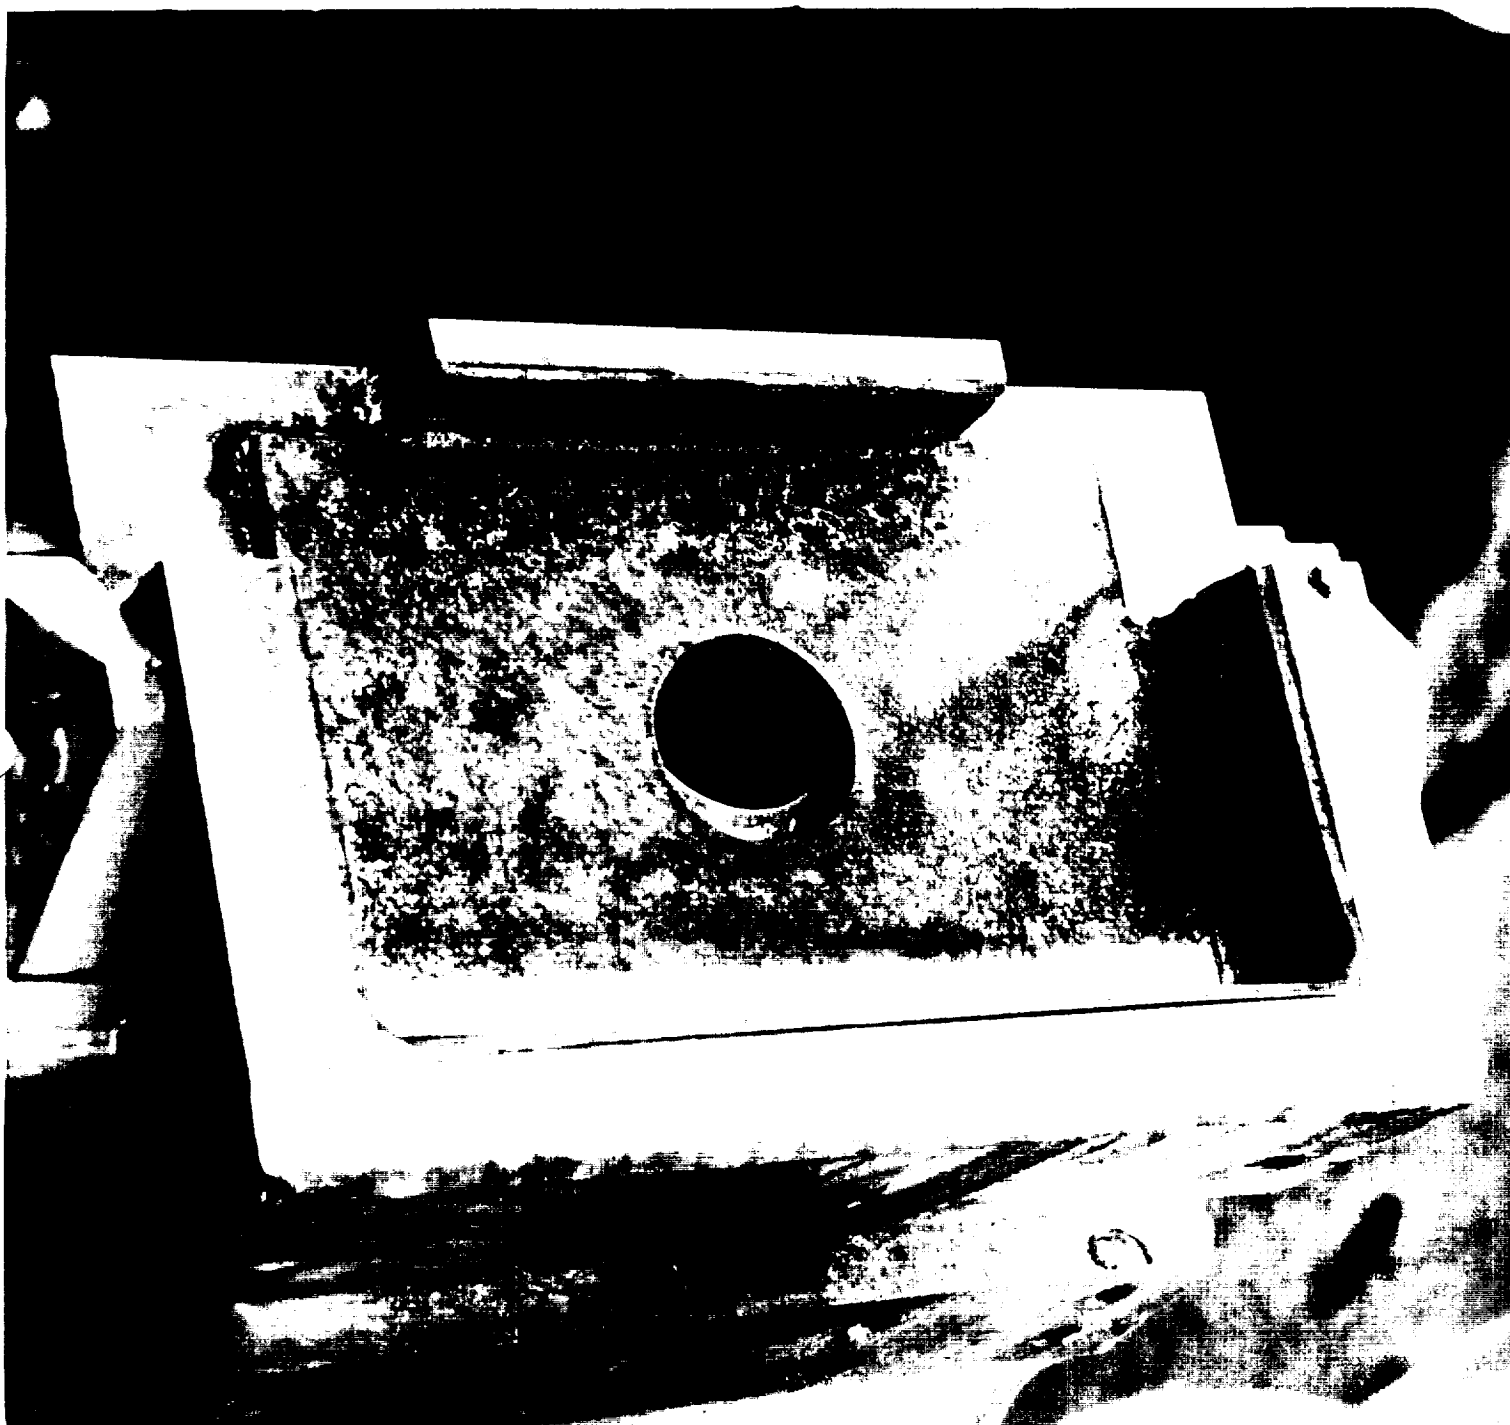
Plume erosion of the south SRB holddown posts was typical. EPON shim material was intact but slightly debonded from the holddown post shoes.

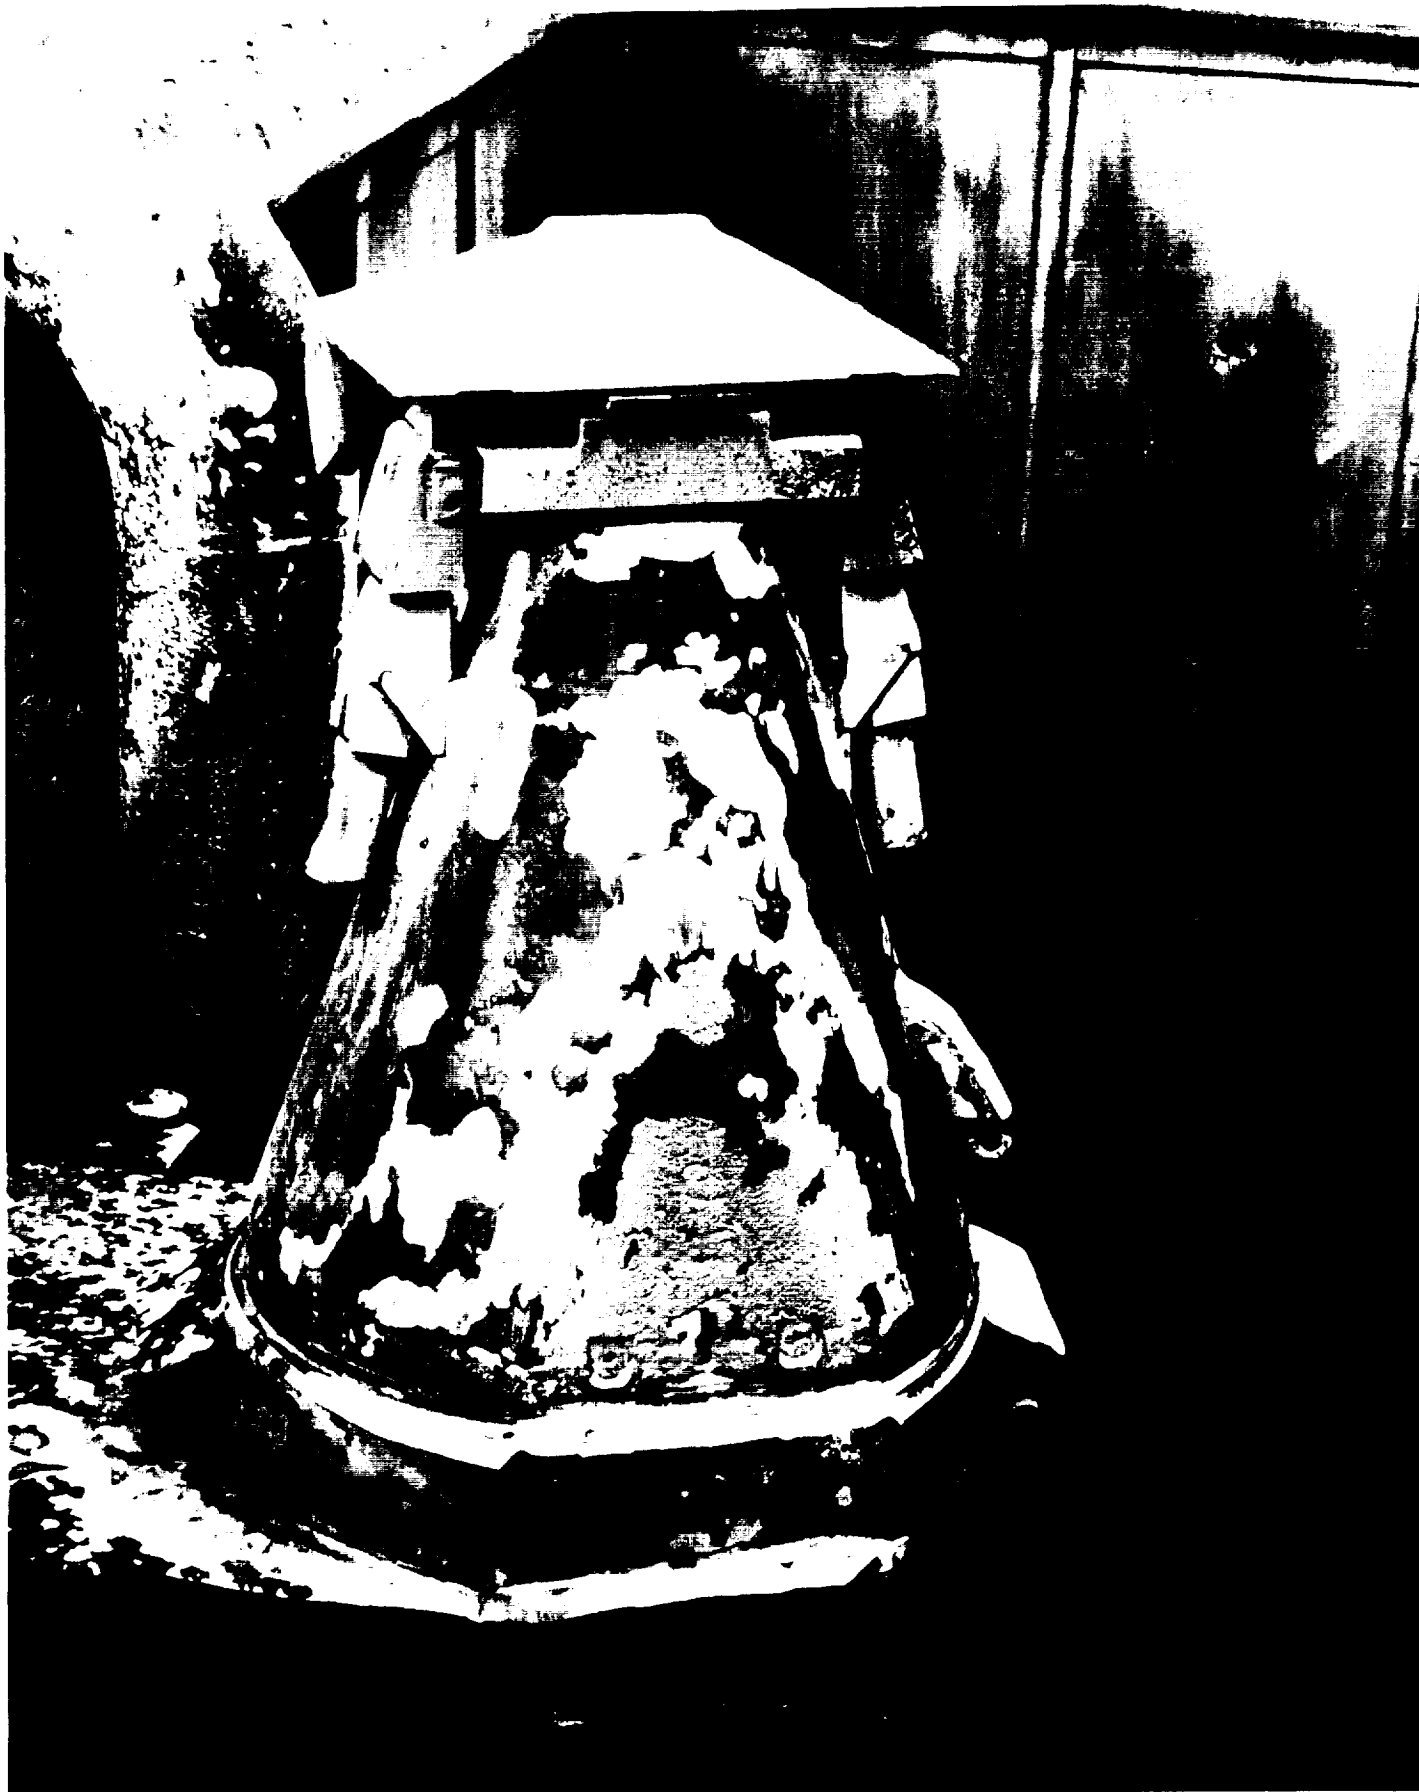
All of the north holddown post doghouse blast covers were in the closed position and showed typical plume erosion

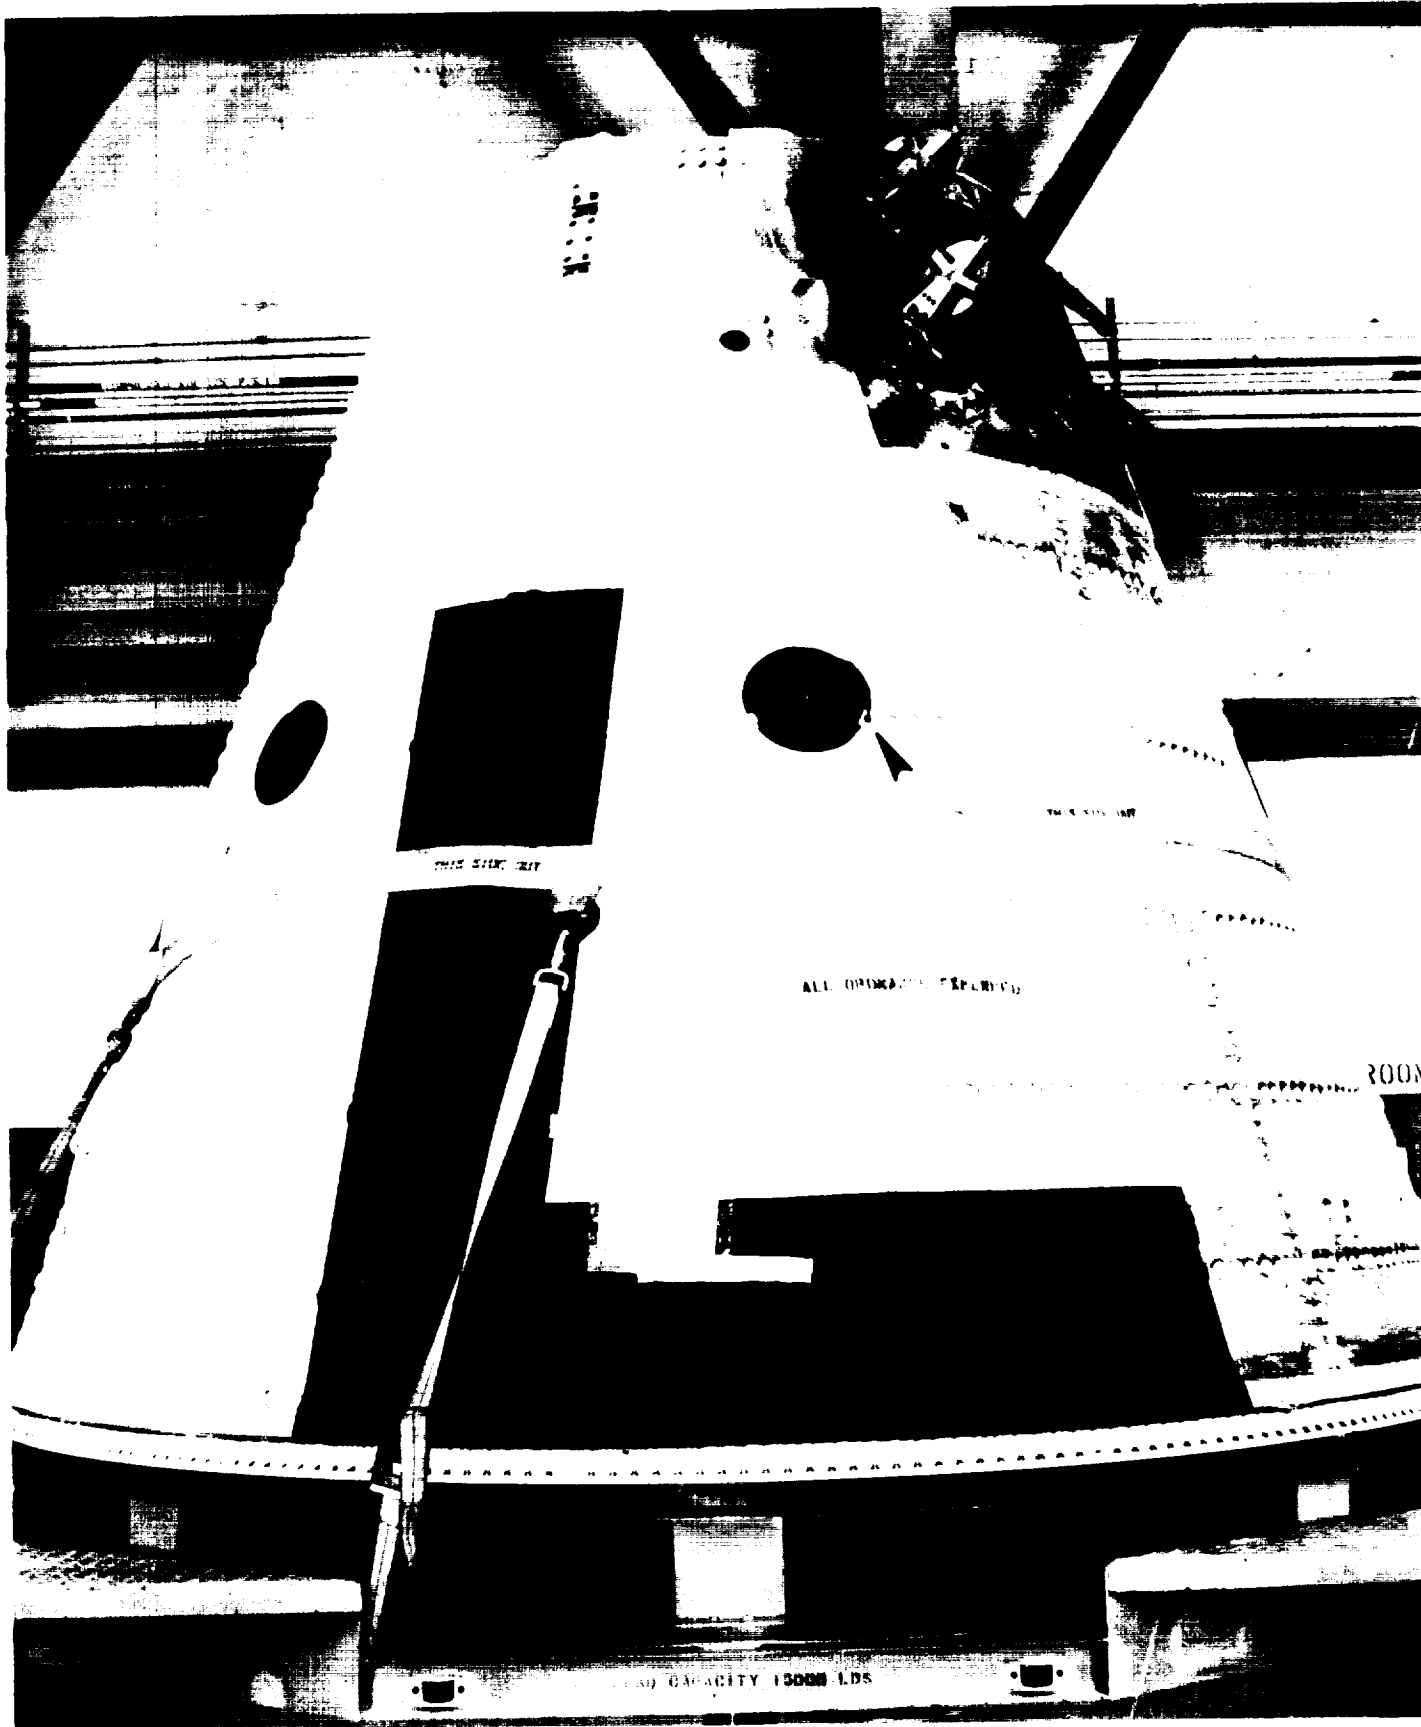
The RH frustum had 18 MSA-2 debonds over fasteners and one area of missing TPS near the pressure port (arrow). All BSM aero heat shield covers were locked in the fully opened position though the left two cover attach rings had been bent by parachute riser entanglement.

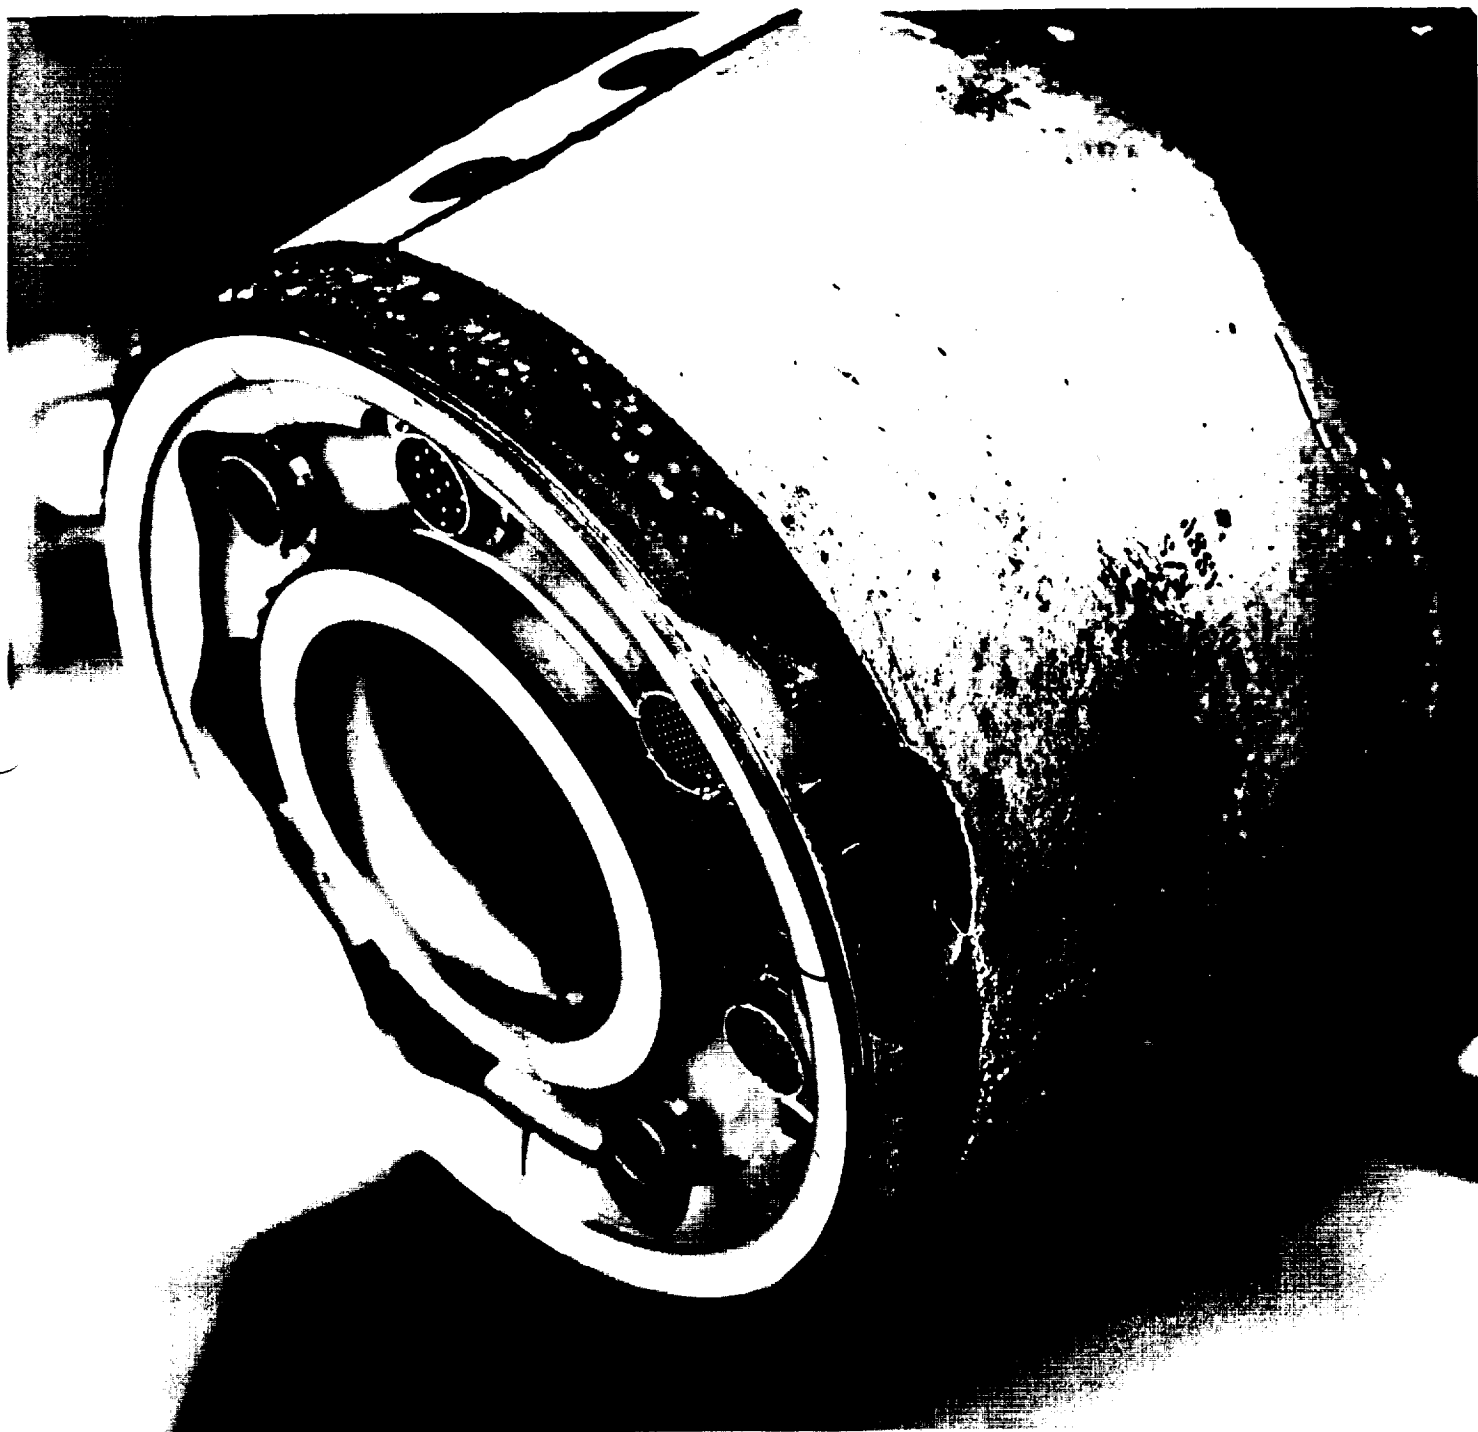
The upper strut fairing (milk can) was missing a 7" x 3" piece of K5NA. The substrate was charred.

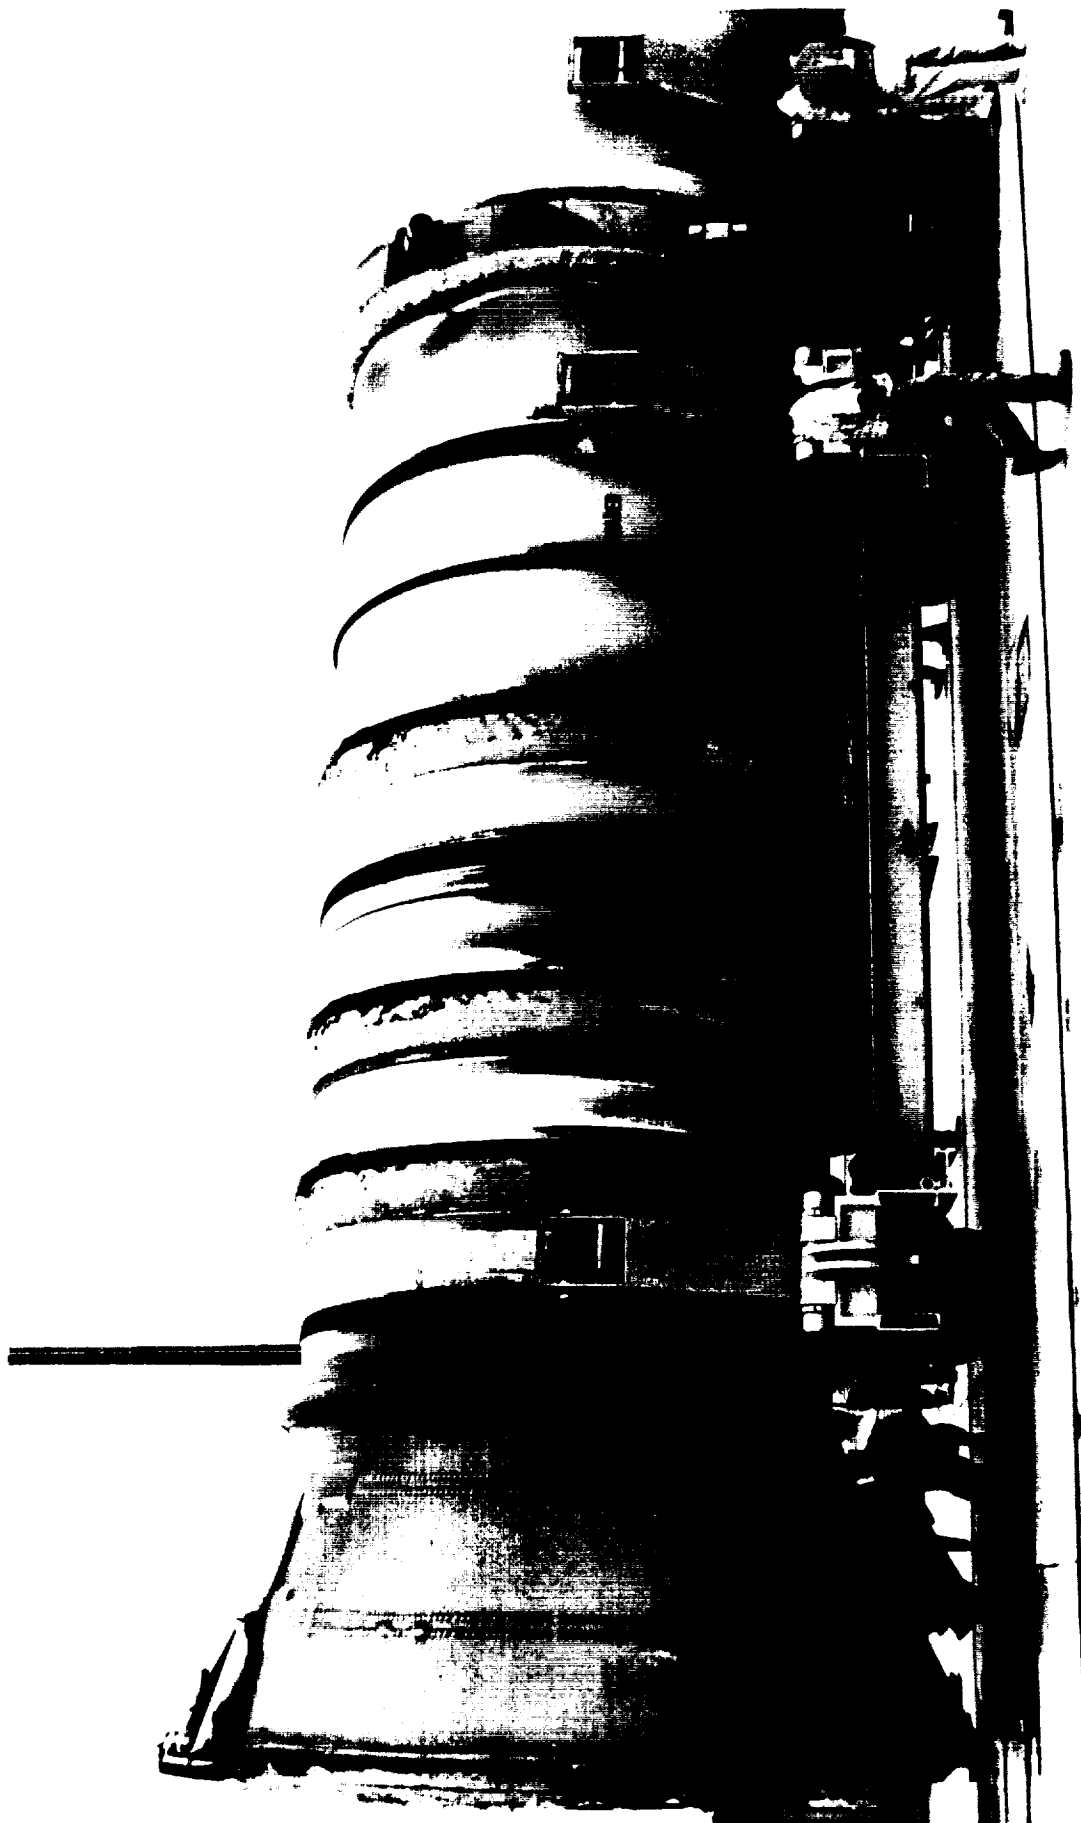
Post flight condition of the RH aft booster. Separation of the aft ET/SRB struts appeared normal. All three aft booster stiffener rings sustained water impact damage.
